McKenzie Lake Scoped Management and Monitoring Plan

Prepared for: McKenzie Lake Property Owners Association

Job #: 210081

Final Report

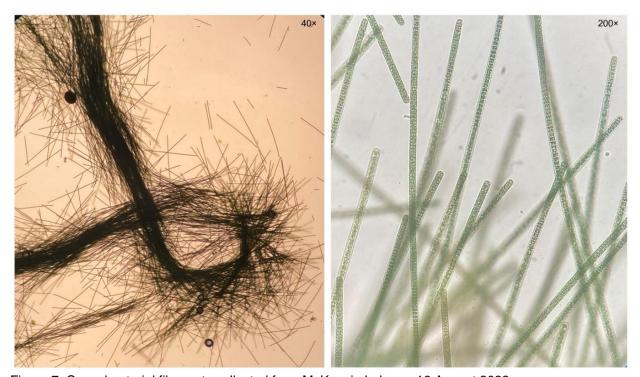
Macroscopic aggregations of phytoplankton (i.e., large particles) were observed dispersed throughout the water column on 16 August 2022. Macroscopic aggregations of phytoplankton have also been observed by residents in recent years (Ursulak, C., personal communication, July 13, 2023). A sample was collected from site ML-3 and the cells (Figure 7) have been tentatively identified by HESL as belonging to the genus *Planktothrix (aka Oscillatoria²)*, a group of filamentous cyanobacteria ("blue-green algae") that is commonly observed in temperate lakes; species of this genus can form surface blooms and may produce toxins (Komárek et al. 2003), predominantly the hepatotoxin microcystin (Kurmayer et al. 2016). However, as noted above, cyanobacteria did not constitute a large fraction of the phytoplankton community at the time of the HESL survey; the majority of the phytoplankton were eukaryotes (algae), which do not produce toxins or form surface blooms in lakes and are an important component of aquatic food webs.

Figure 7. Cyanobacterial filaments collected from McKenzie Lake on 16 August 2022.

- (1) The Spills Action Centre should be called at 1-866-MOETIPS (663-8477) if a cyanobacteria ("bluegreen algae") bloom is suspected in the future. If a bloom is present, MECP will collect samples to determine if cyanobacteria are present and if there is potential for toxins to be produced based on the particular genus or species identified. If it is confirmed that harmful cyanobacteria are present, additional analyses are completed to determine microcystin concentrations and compare concentrations to the drinking water limit of $1.5 \mu g/L$ and recreational limit of $10 \mu g/L$.

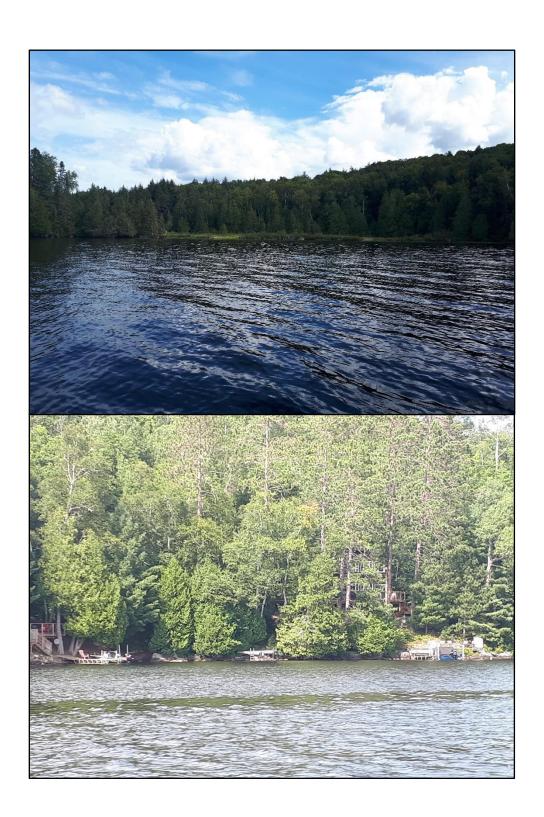
Shorelines link terrestrial and aquatic ecosystems, acting as a transition zone between land and water. They are biological hotspots and highly productive habitats that provide myriad ecological services, including maintenance of water quality, flood protection, and wildlife habitat. Shoreline buffers can play an important role in protecting lake health. The physical separation they provide between upland human activity and the aquatic environment can aid in mitigating the effects of development and site alteration on water quality, erosion and flood control, and wildlife habitat. Much of McKenzie Lake's shoreline is undeveloped (Photograph 1). There is no road access to the SE areas of the lake's perimeter and this land remains in a predominantly forested state. Most of the developed lots on McKenzie Lake were observed to have vegetative buffer zones (i.e., the presence of plants that help to minimize runoff and associated pollutants such as nutrients and soil particles; Photographs 2–4) in accordance with Official Plan policies.

Photographs 1 and 2. Undeveloped shoreline (top) and a view of waterfront development along the northern shoreline exhibiting intact natural vegetated buffers (bottom).

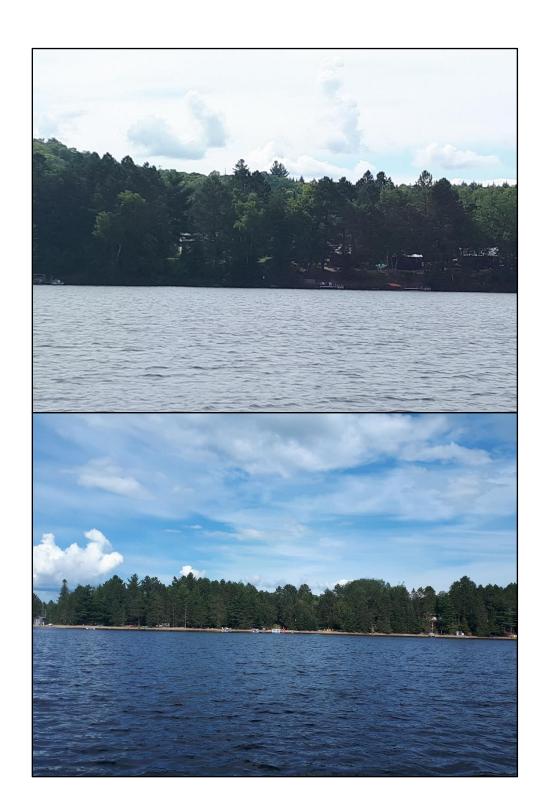
Photographs 3 and 4. Another example of waterfront development that is well buffered from the lake (top) and a representative view of development on the northeastern shoreline where beachfront is present.
